HYDRAULIC INDUCED INSTABILITY ON A VERTICAL SERVICE

WATER PUMP: CASE HISTORY

R.F. Bosmans
Bently Rotor Dynamics Research Corporation
Minden, Nevada 89423

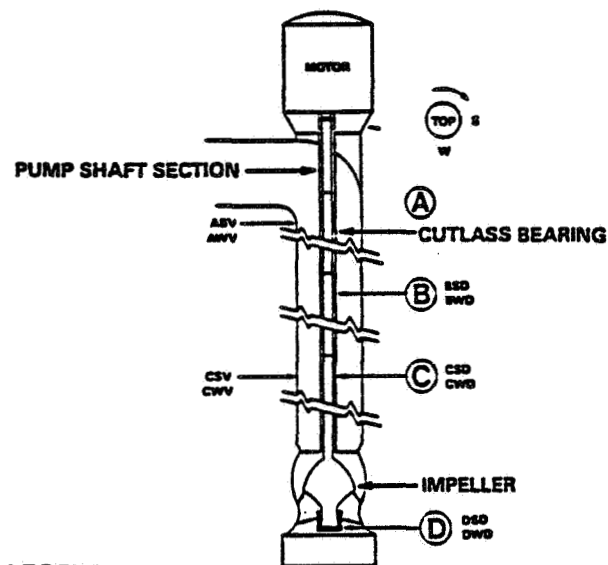
Figure 1. - Vertical low-pressure service water pump.

An outline drawing of this pump and motor is shown in figure 1. A number of shafts on this specific pump had failed in recent years for unknown reasons. The lower bearing consists of a grease-lubricated bronze bushing supported by the pump end bell. Intermediate "bearings," supported by the pump vertical column, are water lubricated and lined with scalloped rubber. This type of bearing is sometimes referred to as a "cutlass" bearing or bumper. The couplings between the shaft sections are rigid and transmit torque through two keys spaced 180° apart. For example, the transducer identified as DWD in figure 1 is located at the bottom bearing and is the west proximity probe. The rated pump performance is

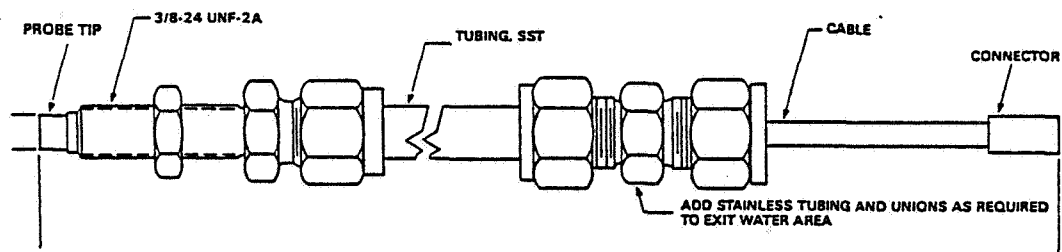
Figure 2. - Waterproof proximity probe transducer.

Since very little information is available on the rotordynamic characteristics of this type of pump, proximity and velocity transducers were installed at each bearing and at the motor coupling. Locations are shown on the pump outline drawing. The transducers are identified by a three-letter code shown in the legend in figure 1. Transducers at locations C and D were below the river level and had to be water-proof. The transducer also had to be designed to provide mechanical protection and to survive the abrasive action of sand in the flowing water. Figure 2 is an outline drawing of the probe design used.

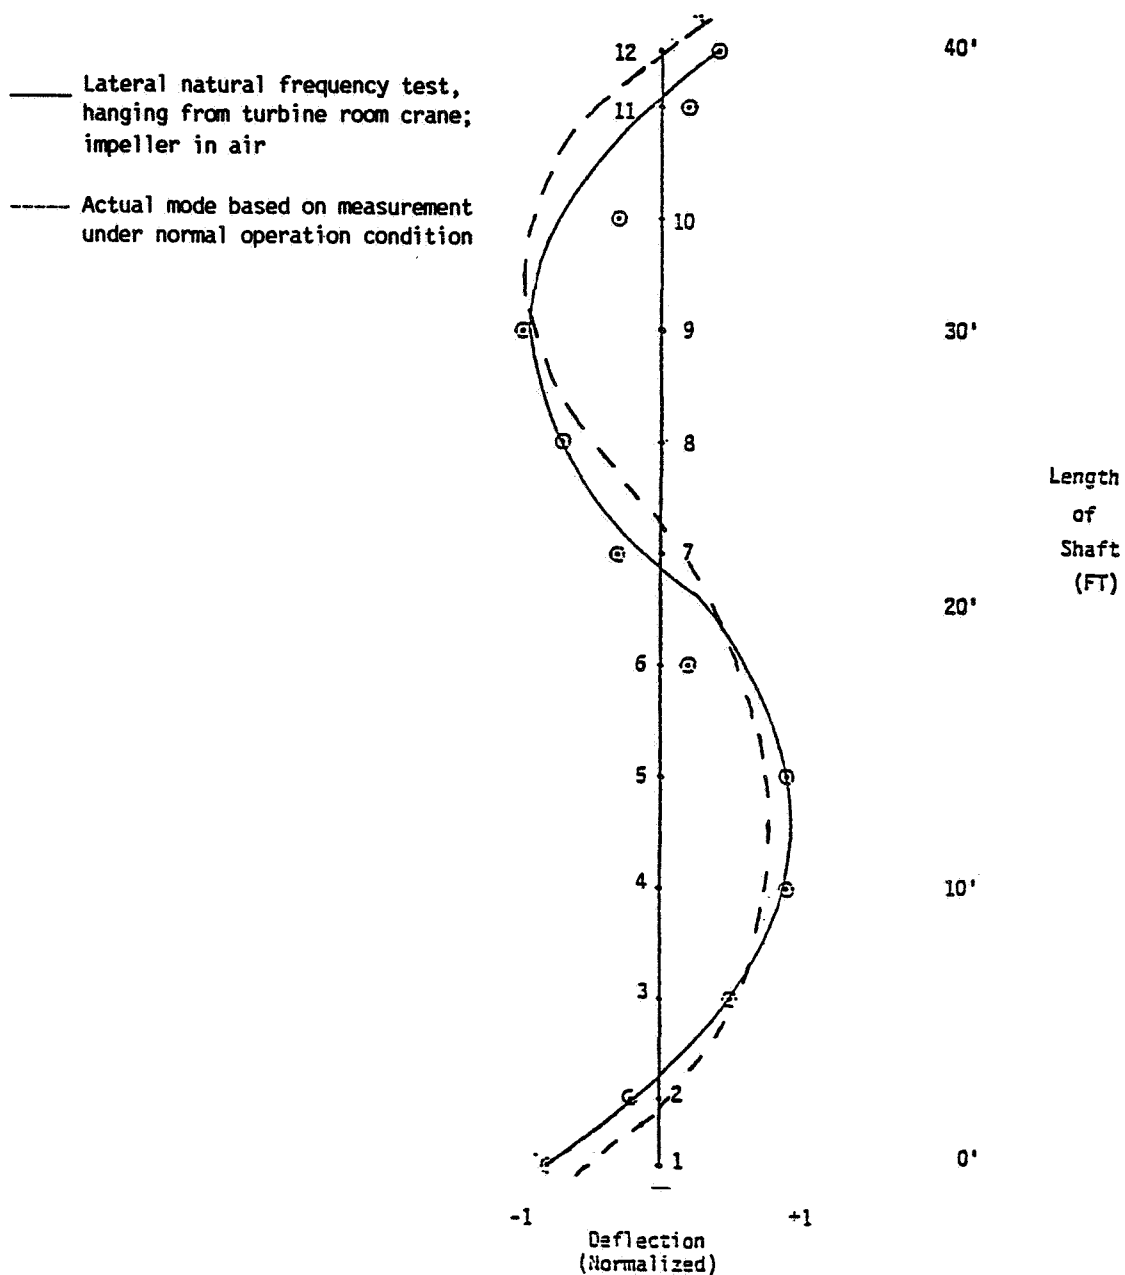
Figure 3. - Mode #2 at 525 cpm.
